# PLANNING APPLICATION NUMBER:P12/1413

Type of approval sought	Tree Preservation Order
Ward	Cradley and Wollescote
Applicant	Mrs S. Powell
Location:	<b>NETHEREND UNITARIAN CHAPEL, PARK LANE, CRADLEY, HALESOWEN, B63 2NU</b>
Proposal	<b>FELL 5 LIME TREES AND 1 BEECH TREE. POLLARD 7 LIME TREES.</b>
Recommendation Summary:	<b>APPROVE SUBJECT TO CONDITIONS</b>

**TREE PRESERVATION ORDER NO: D323 (1991) – G2 & G3 & T5, T6, T10, T11**

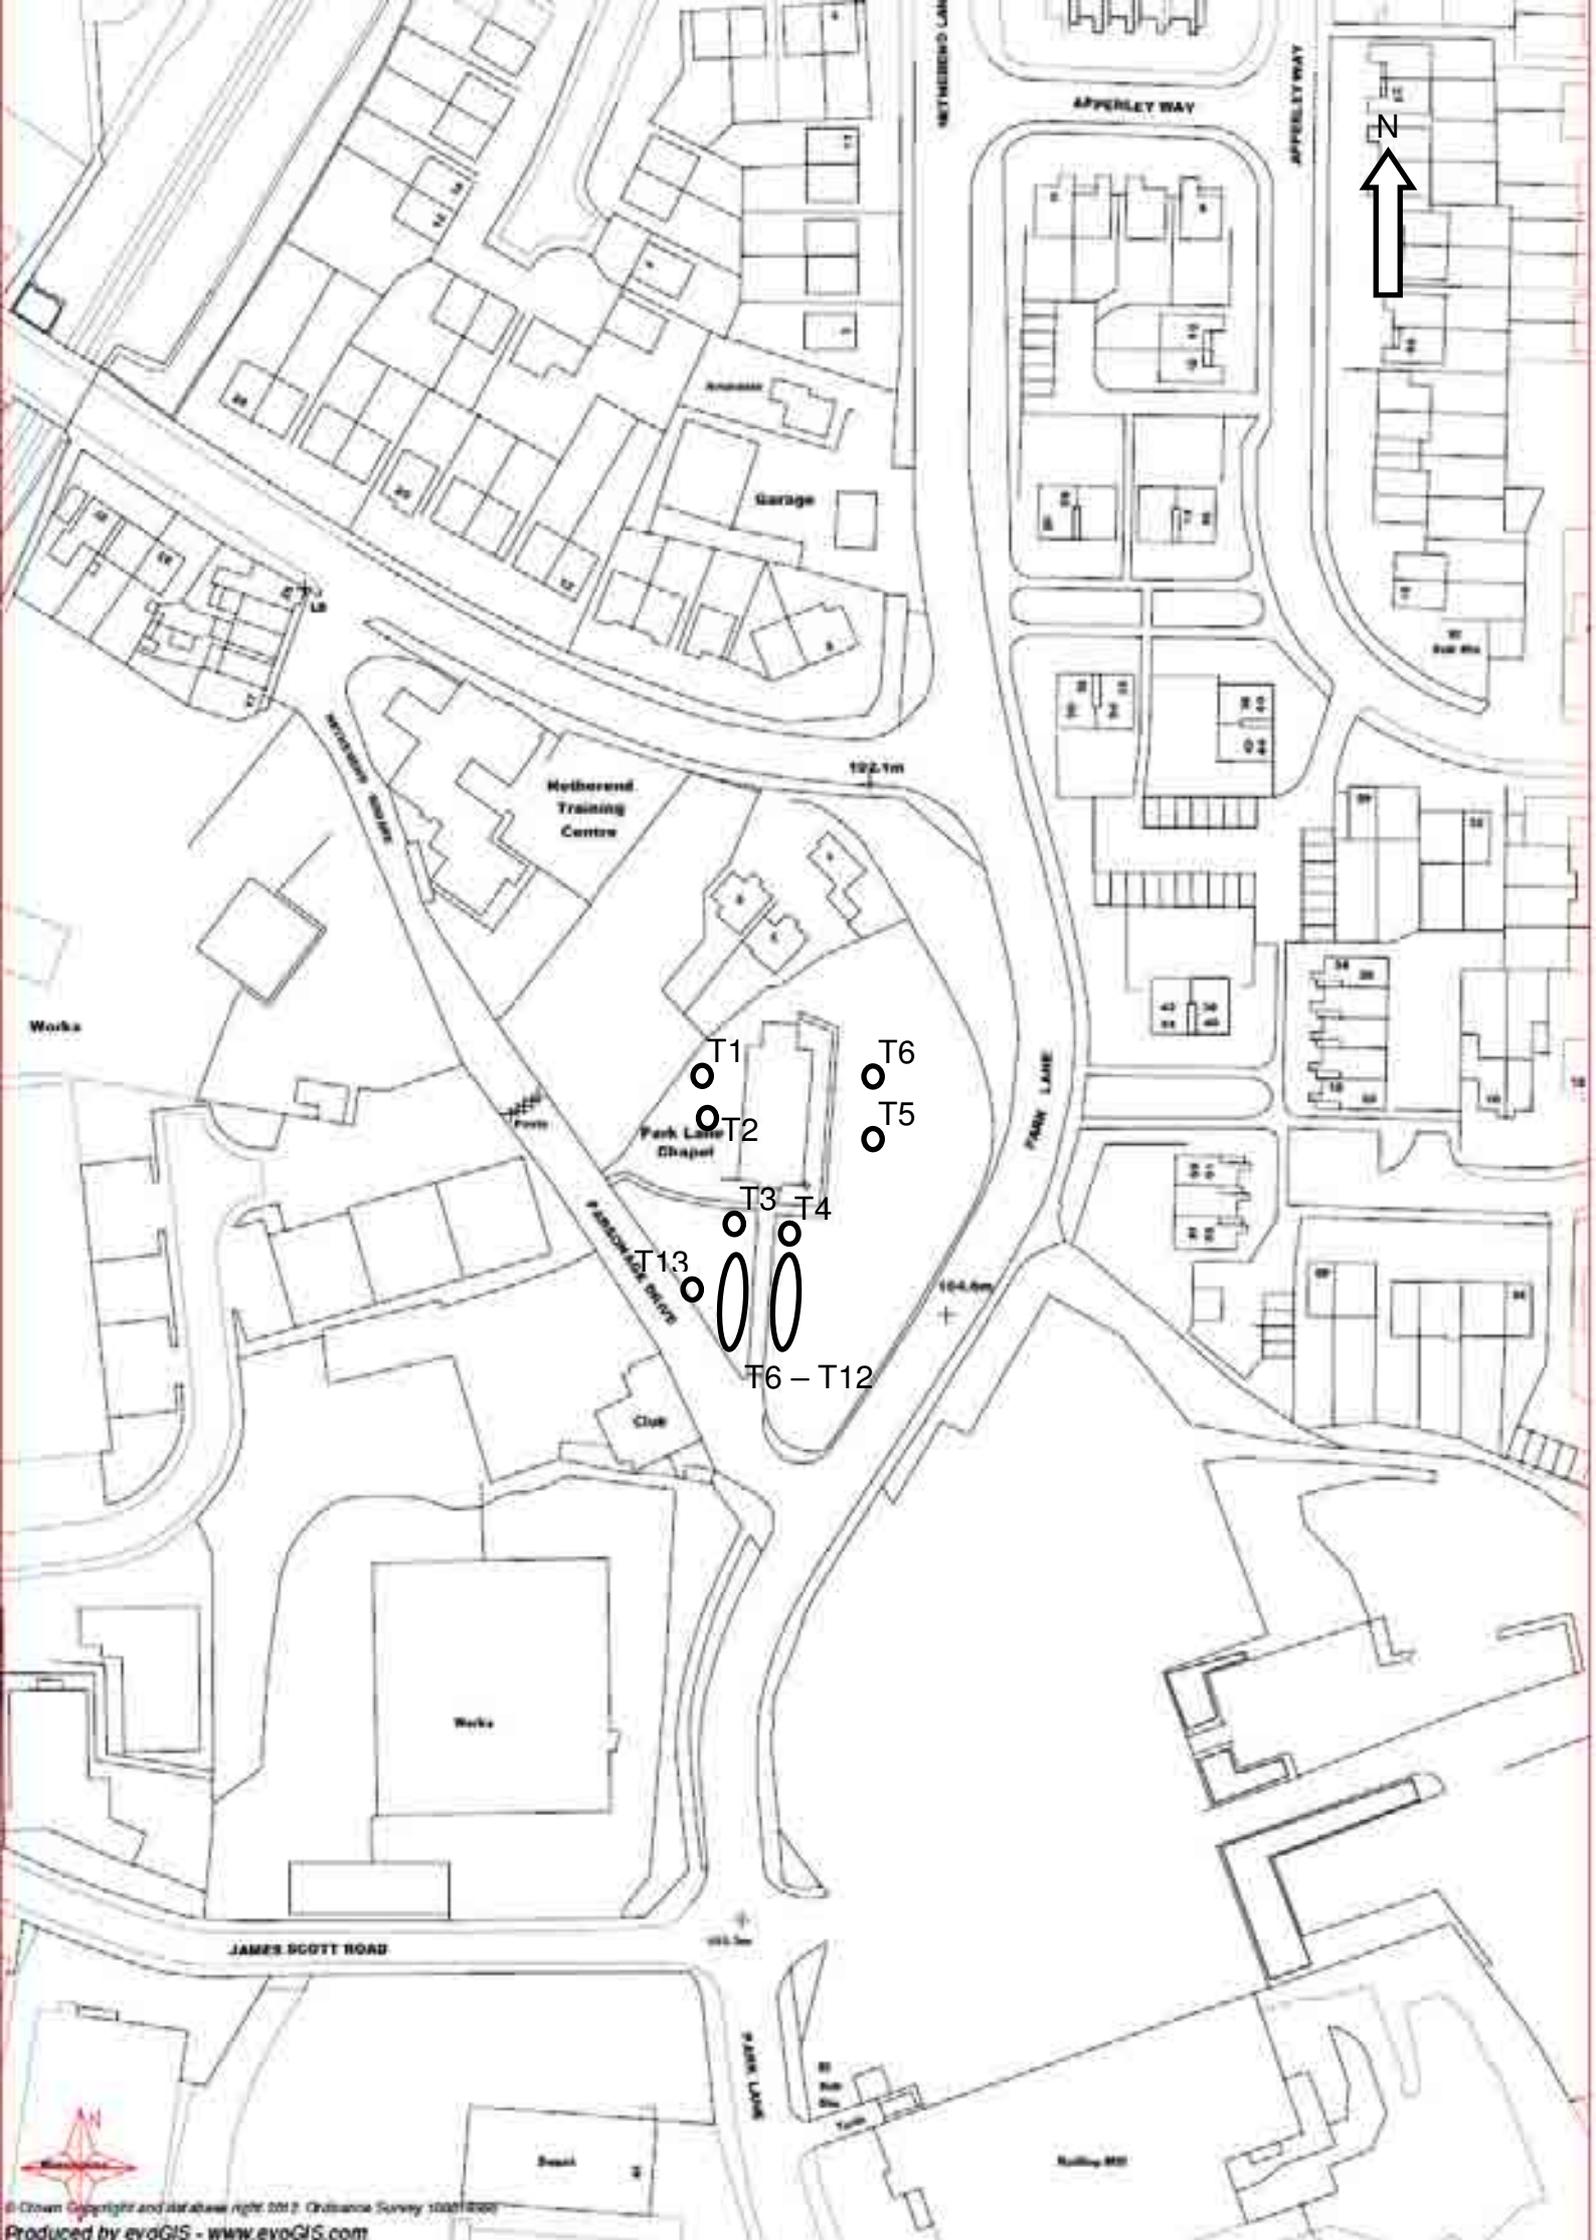
3. Summary of proposals for the works as written on application form is as follows:
  - Fell 5 Lime trees and 1 Beech tree; Re-pollard 7 Lime trees and.
4. The trees have been marked on the attached plan.
